Mahone Bay Living Shoreline Monitoring Summary 2021 – 2023

Prepared for Coastal Action

By Leah Rudderham, Kelly Umlah, Christian Hart, Danika Van Proosdij

TransCoastal
Adaptations
Centre for Nature-Based Solutions

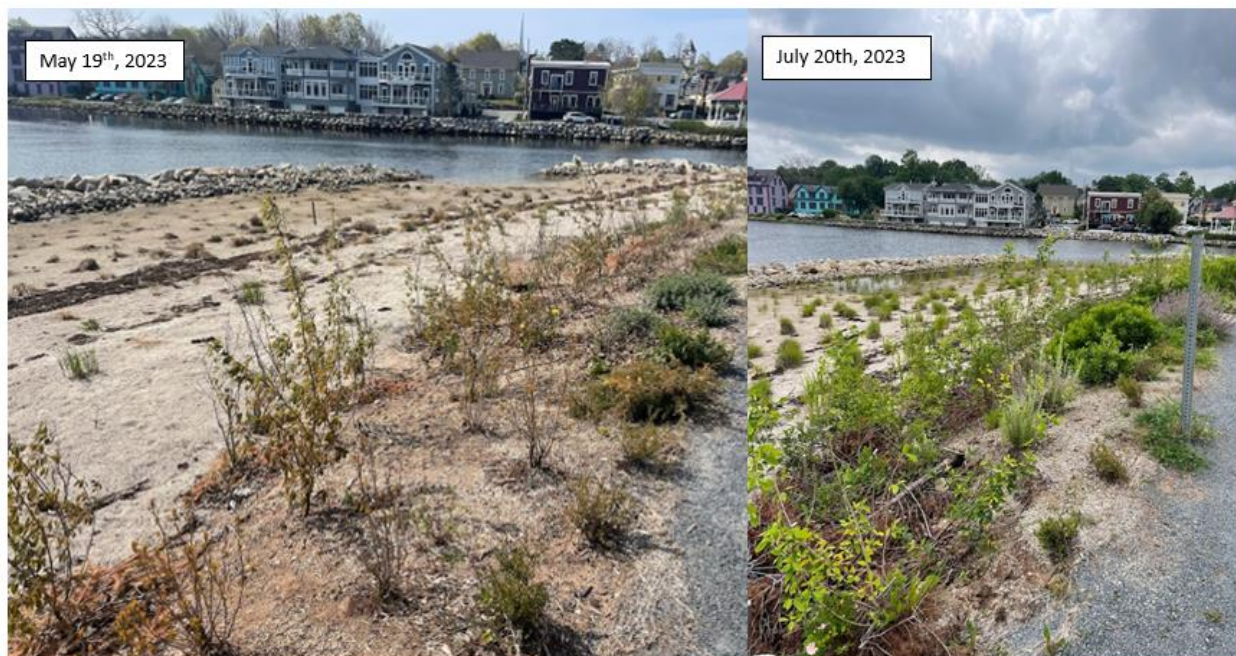
In the spring of 2023, the marsh grasses planted in the fall came back to life and shrubs on the vegetation bank started to bud and eventually bloom. Native honeybees were noticed to be attracted to the vegetated bank and the shoreline became quite lush and beautiful by mid-summer.

Figure 2: Vegetation growth in the spring/summer of 2023.

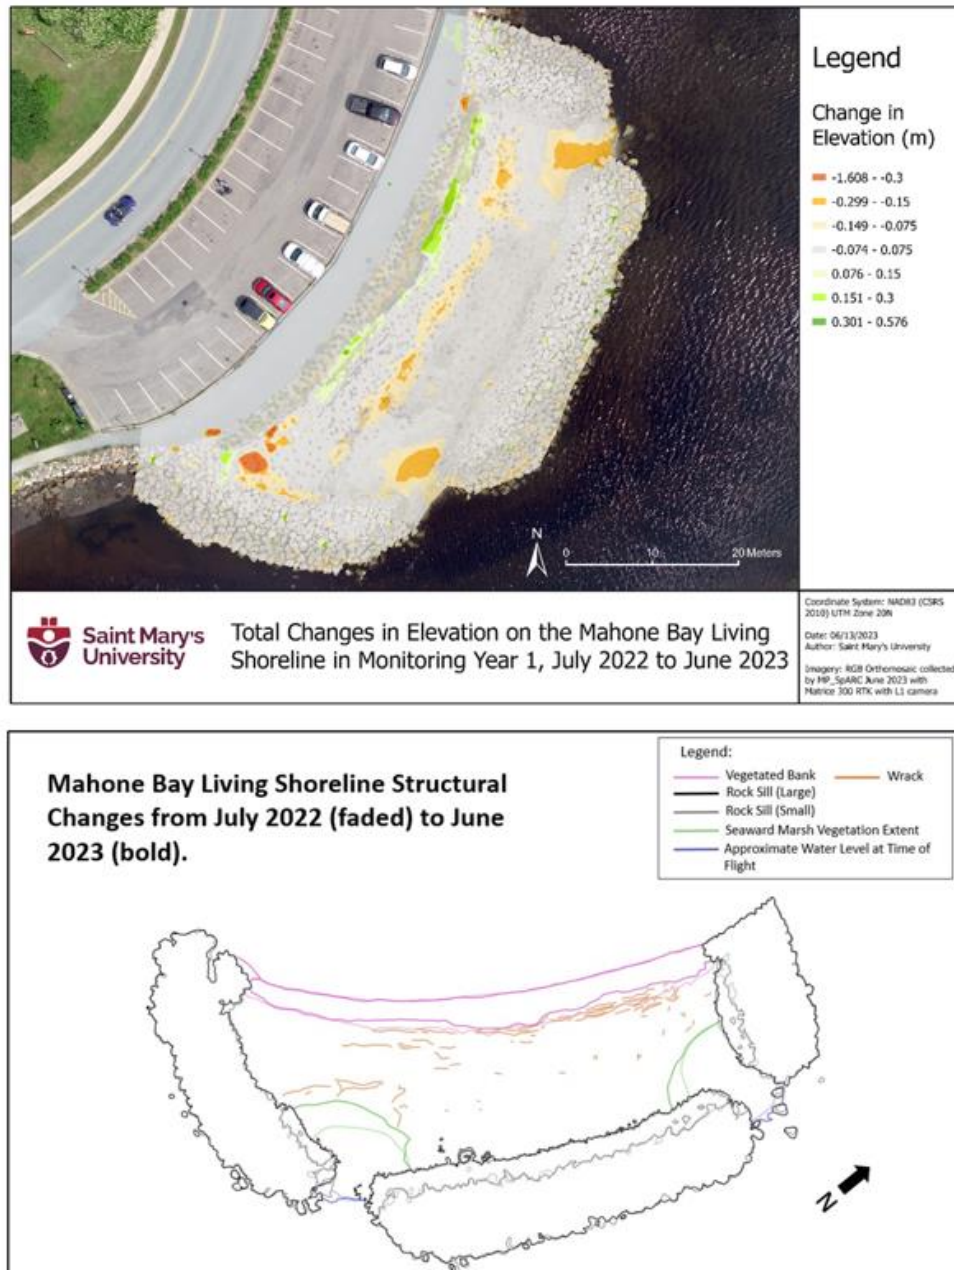
Using a Digital Elevation Model (DEM) and various modelling techniques, TCA mapped the changes in both elevation and structure of the shoreline that happened between each flight. As expected, some sand redistribution occurred between the construction and summer of 2023, driven by high tides and waves creating a more natural topography. Some small scour was visible on the landward side of the marsh sill but this filled in over time. Some rocks were observed to have been physically re-arranged in patterns on the beach and this activity should be discouraged as it creates scour. Changes in elevation and the shoreline structure between July 2022 and June 2023 are shown in figure 4.

Figure 4: Left: Changes in elevation between July 2022 and June 2023. Right: Shoreline structural changes from June 2023 to October 2023; Figures created by Kelly Umlah and Greg Baker. Note, most of the changes reflect growth of vegetation.

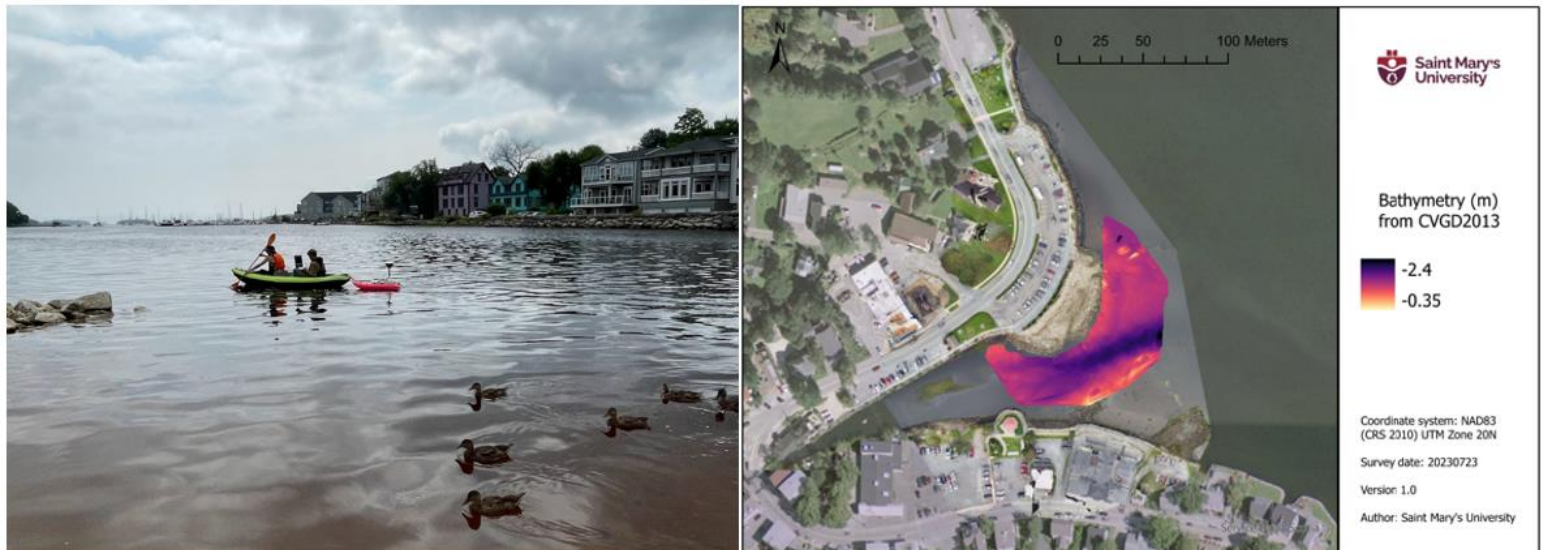
The image below (Figure 5) shows the results from the 2023 bathymetric survey. The pink-purple shading shows the entire survey area, and the darker purple areas represent deeper water, such as the outflowing channel of Ernst Brook. Combined with visual observations on site, the data indicate that some sand was removed from the eastern 'beach' between the rock sill and this was deposited in a small lobe at the base of the opening. No scour was recorded at the base of the rock sill. Subsequent visual observations indicate that this material was transported landward and returned to the beach by wave action during normal conditions.

Figure 5: Left: Sontek M9 river surveyor being towed by TCA staff, picture taken by Leah Rudderham. Right: visualization of M9 survey results completed by Christian Hart.

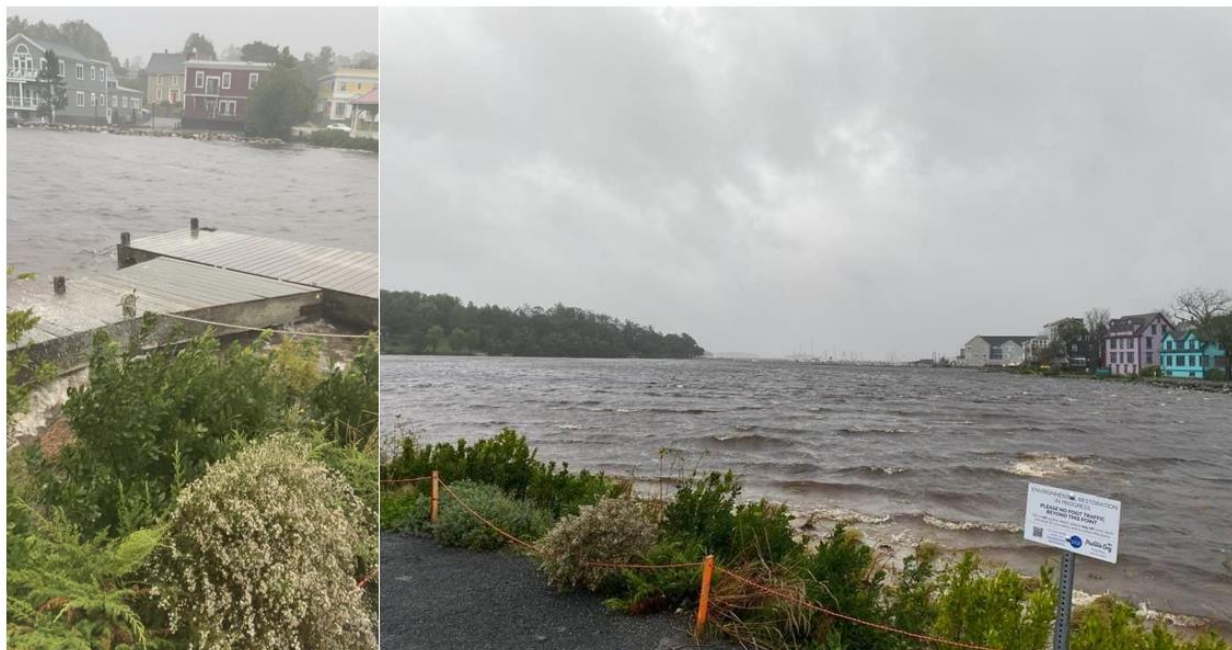
Tropical storm Lee brought high winds, rain, waves, and a storm surge to Mahone Bay, on the living shoreline significant wave height peaked just above 0.3m and wave energy reached $60 \text{ J} \cdot \text{m}^{-3}$. Wave height reached a maximum of 0.33m. Photos captured by a community member showed the rough water conditions that submerged the whole shoreline, at the peak of the storm water level was level with the vegetation bank and flooded areas of the walking path along the waterfront. The storm left a dock as well as other woody debris on the shoreline, some vegetation plugs were ripped out but minimal erosion occurred within the site.

Figure 6: Images of the living shoreline on September 16th during the post-tropical storm Lee.

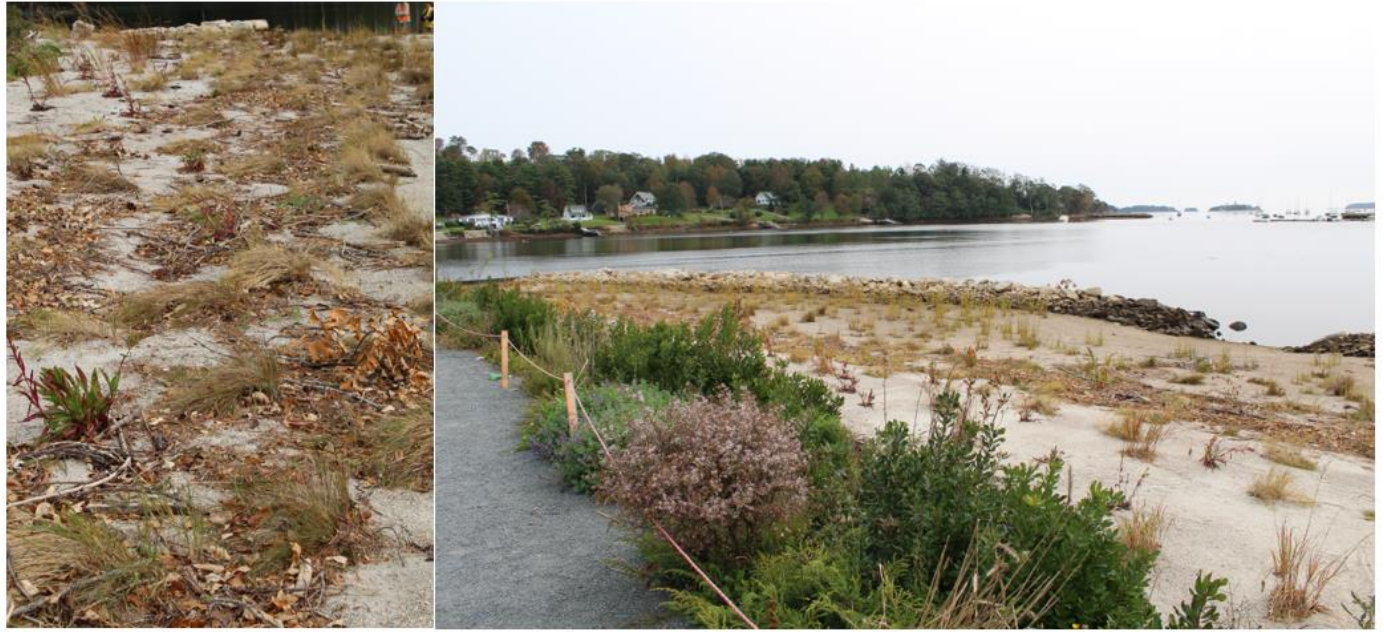
TCA visited the shoreline the week after to record damage and complete a drone survey. Tropical storm Lee really tested the shoreline’s ability to weather storms, overall damage on the shoreline was very minimal it proved to be very effective at protecting the walking path alongside it. After the storm other areas of the waterfront appeared more battered with debris and areas of erosion and scour were noted along the path, above the rock armour stone along the waterfront.

Figure 8: Debris left on the living shoreline after post-tropical storm Lee, photos taken by Leah Rudderham.

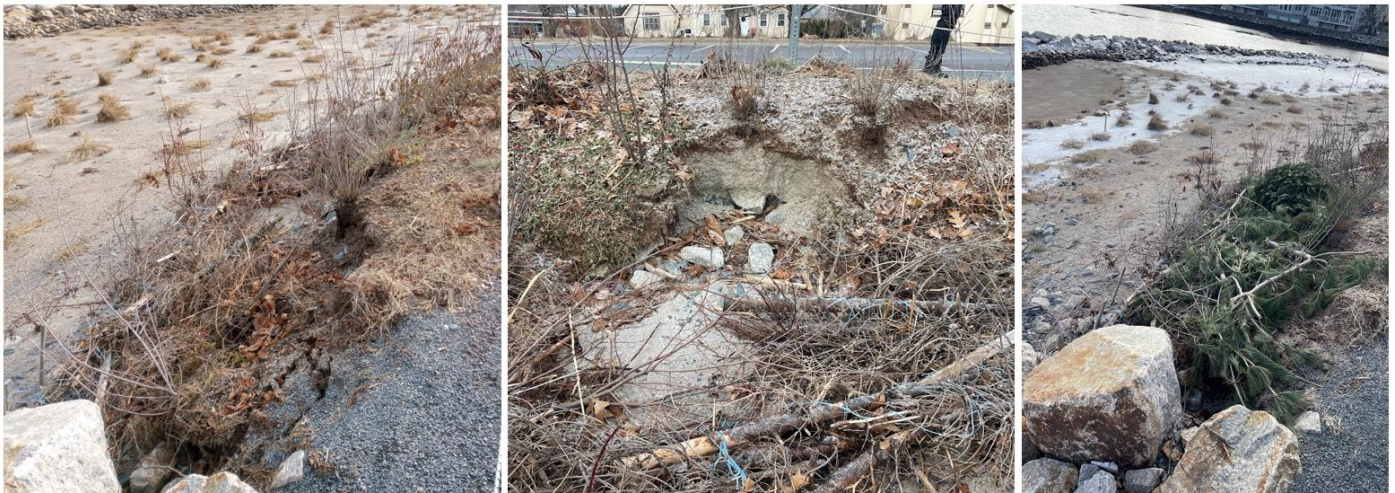
Heavy rainfall and winter storms battered the shoreline in December and January, combined with multiple freeze/thaw periods, some areas of the vegetated bank that already had some erosion lost more sediment; leaving the roots of some of the vegetation exposed to cold temperatures and winter conditions. Three consecutive storms at very high tide levels caused erosion along an approximate 3 m section of the vegetated bank on the eastern side of the site. This location is most exposed to higher waves travelling through the gap in the sill. To attempt to protect the bank from further erosion, Christmas trees and pine branches were woven between the standing vegetation. Further work to add more sediment and replace vegetation that may not survive the winter due to root exposure will be planned in the spring.

Figure 10: Erosion due to winter storms (left and centre), adaptive management using branches and Christmas trees to protect the bank from future winter storms (right).
