Mahone Bay Living Shoreline Monitoring Summary 2021 – 2023

Prepared for Coastal Action

By Leah Rudderham, Kelly Umlah, Christian Hart, Danika Van Proosdij

TransCoastal
Adaptations
Centre for Nature-Based Solutions

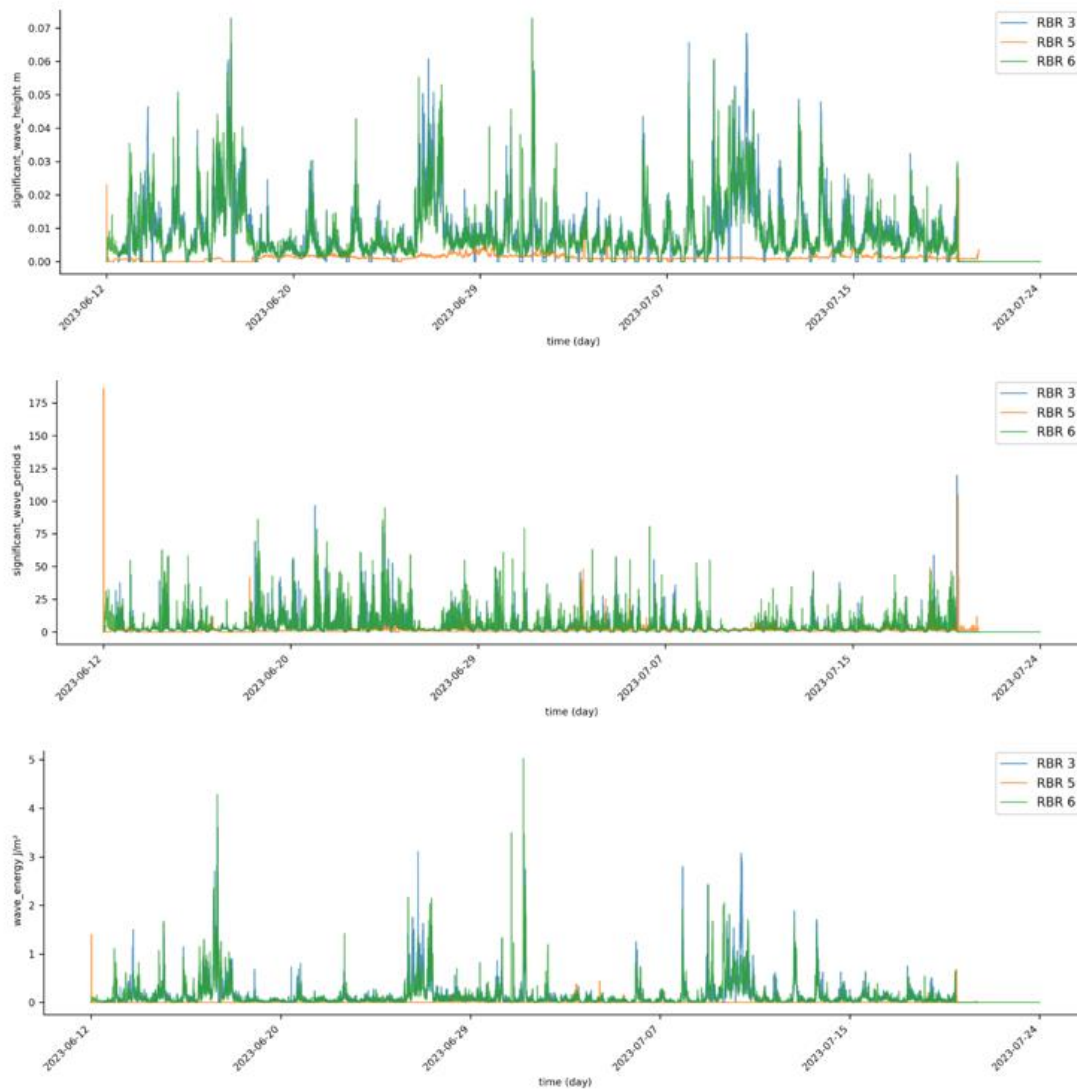
Wave conditions measured between April 14th- May 23rd and June 12th- July 20th of 2023 showed the relatively calm wave conditions that are typically observed on the shoreline. Significant wave height is defined as the average wave height of the highest third of the waves, this is defined in a way that it can correspond to what a mariner observed when visually estimating the average wave height. In the spring significant wave height conditions range between 0.01 – 0.14 meters, and typical wave energy is under 5 Joules. A joule (J) is the energy needed to lift 1 kilogram of matter 1 meter at sea level, significant wave height conditions were slightly lower in the summer months compared to the spring, they ranged between 0.01m – 0.07m, the maximum wave height recorded during this time was 0.14m. The following figures show the significant wave height and energy captured from a logger placed in the centre of the shoreline.

Figure 3: Significant wave height, significant wave period, and wave energy (J/m^2) for the RBR's deployed from June 12th – July 20th, 2023. Loggers were deployed at low tide, RBR 3 and RBR 5 were located in the water where at each gap in the bulkhead where the tide enters the shoreline. RBR 5 was located in the centre of the shoreline.

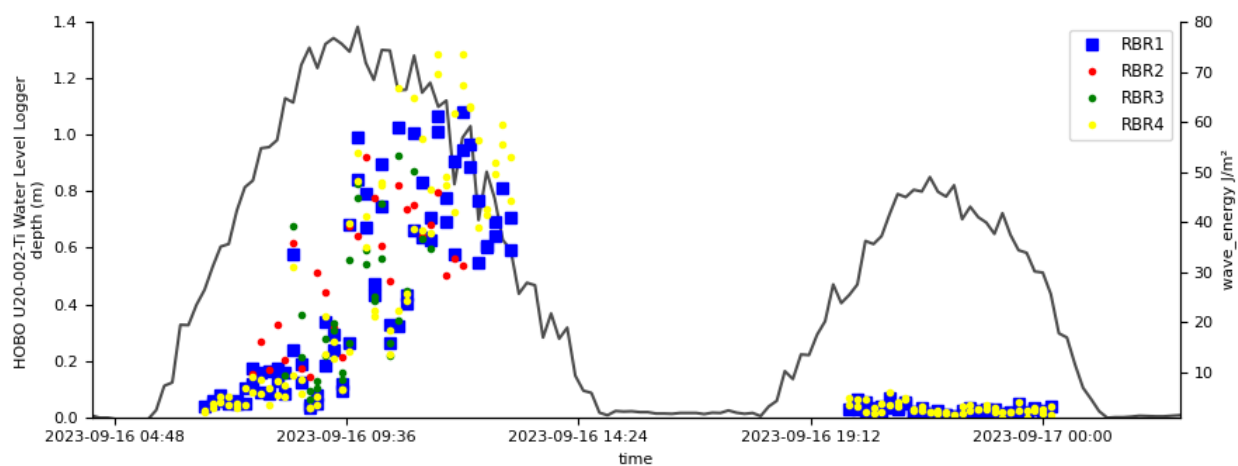
Tropical storm Lee brought high winds, rain, waves, and a storm surge to Mahone Bay, on the living shoreline significant wave height peaked just above 0.3m and wave energy reached $60 \text{ J} \cdot \text{m}^{-3}$. Wave height reached a maximum of 0.33m. Photos captured by a community member showed the rough water conditions that submerged the whole shoreline, at the peak of the storm water level was level with the vegetation bank and flooded areas of the walking path along the waterfront. The storm left a dock as well as other woody debris on the shoreline, some vegetation plugs were ripped out but minimal erosion occurred within the site.

Figure 7: Water level and wave energy conditions observed during post-tropical storm Lee. Water depth is shown on the left axis and is represented by the solid black line, the first “hump” being the tide that occurred during the storm. The colored boxes refer to the wave energy on the right axis that was captured by various wave loggers. Maximum wave energy peaked just after high tide at just over 60J. RBR 1 was located at the lowest elevation, RBR 2 and RBR 3 were in a transect with RBR 1, RBR 4 was located in the middle of the marsh sill. Figure produced by Christian Hart.

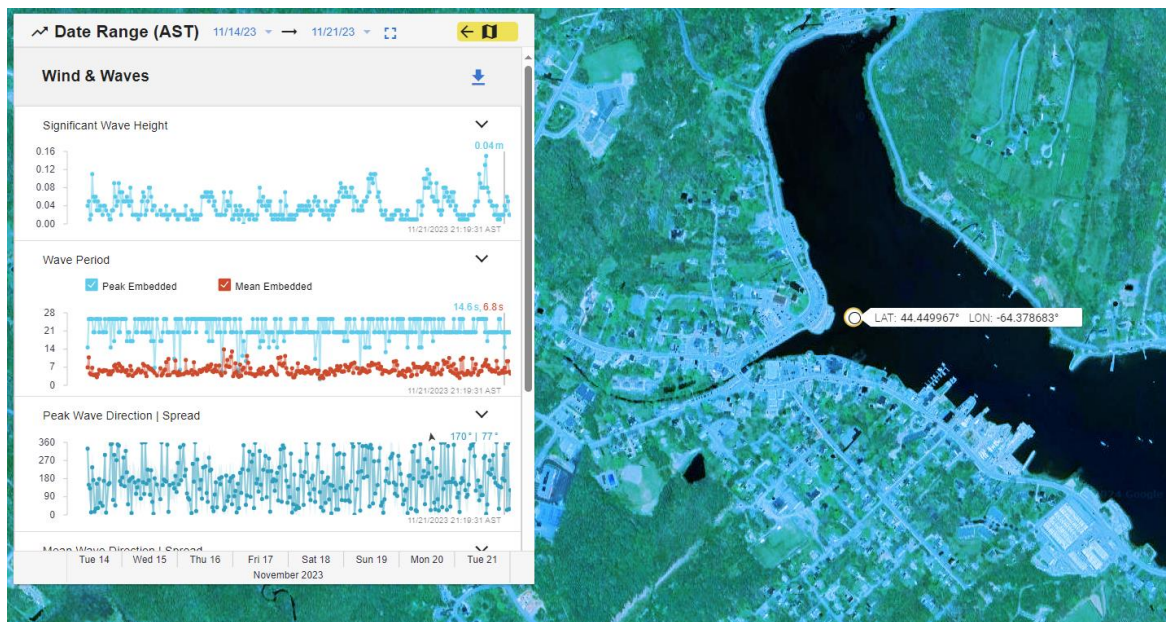
Figure 9: Conditions reported from the Sofar wave buoy from November 14th - 21st, 2023. Located just offshore from the living shoreline, significant wave height ranged from 0.01 - 0.13m. Wave period ranged from 14 - 27s. The buoy also reported on wave direction, wind direction, wind speed, and surface temperature.

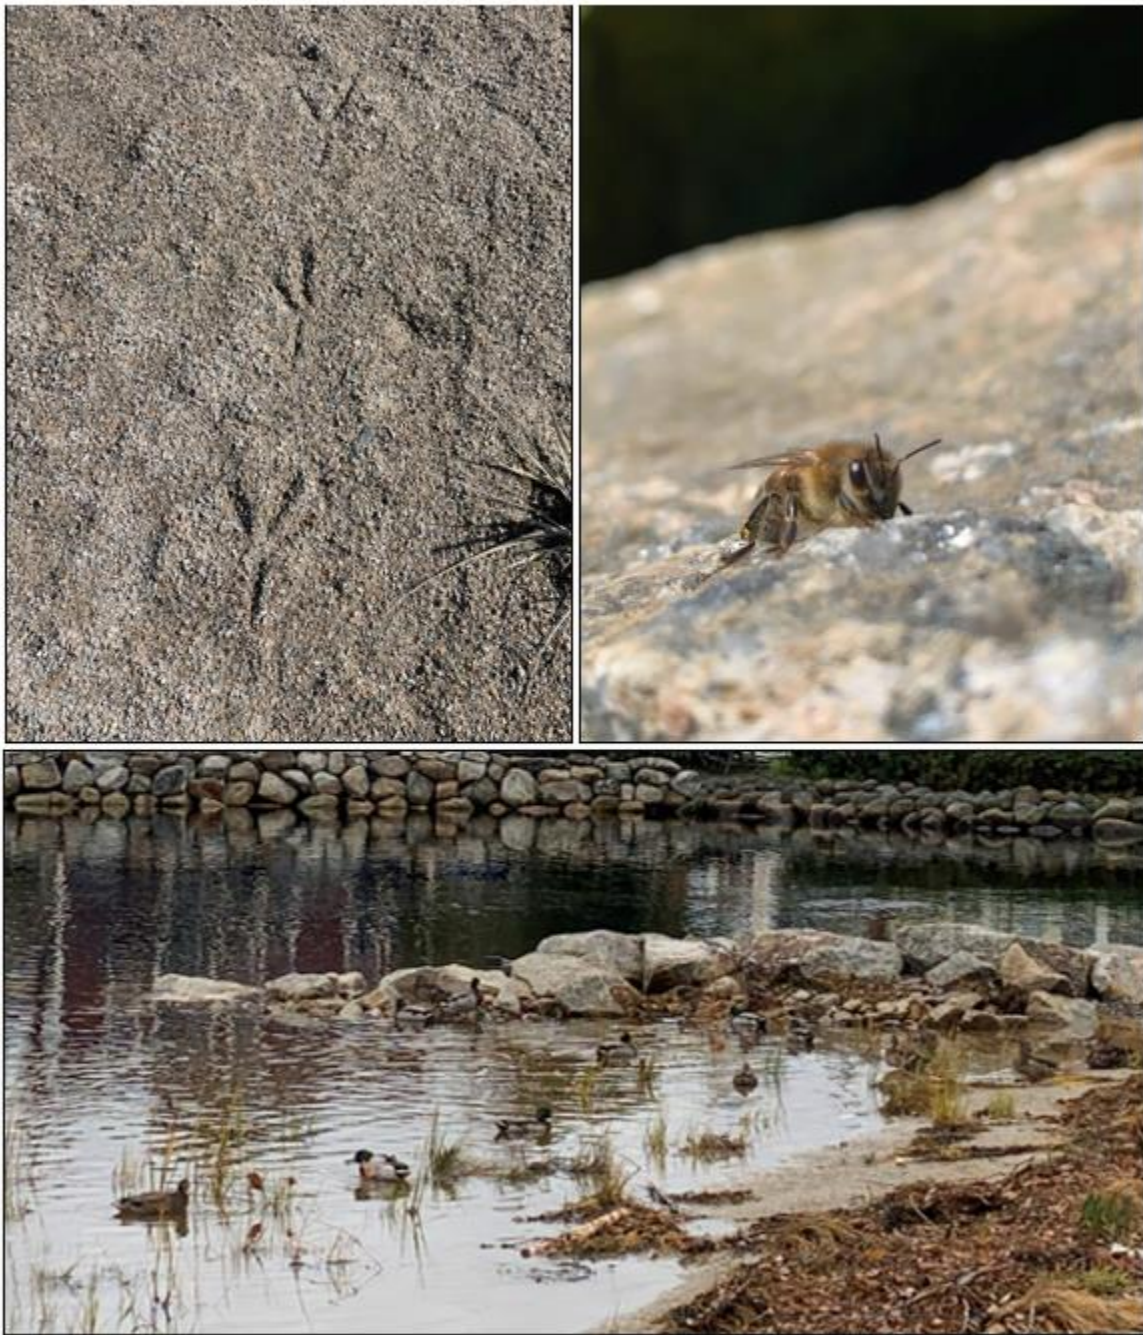
Figure 11: Great Blue Heron (Ardea herodias) footprints on the Mahone Bay living shoreline (left), Native honeybee spotted resting near the vegetation bank (right), June 2023. Mallards resting along the shoreline (bottom, September 2023).
